INSPECTION REPORT

For the Property at:
21309 WOODHILL DR.
FARMINGTON HILLS, MI 48167

Prepared for: SHRIDHAR KULKARNI
Inspection Date: Saturday, December 4, 2010
Prepared by: David Richardson

RE: Report No. 1845
21309 Woodhill Dr.
Farmington Hills, MI
48167

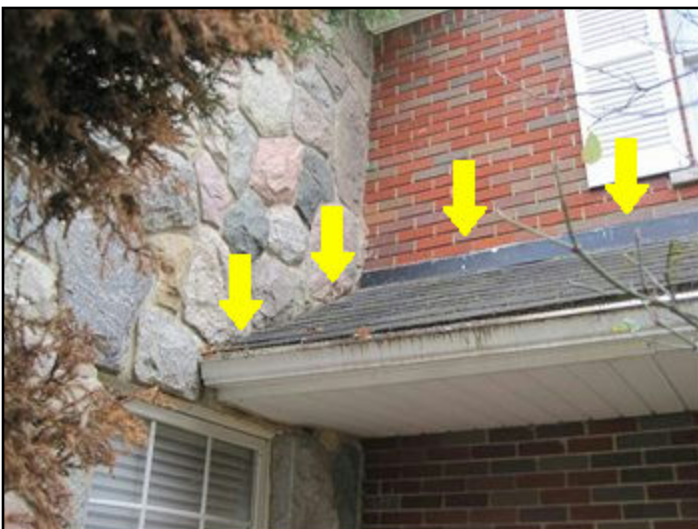
1. Flashing/caulking needed at re-roof.

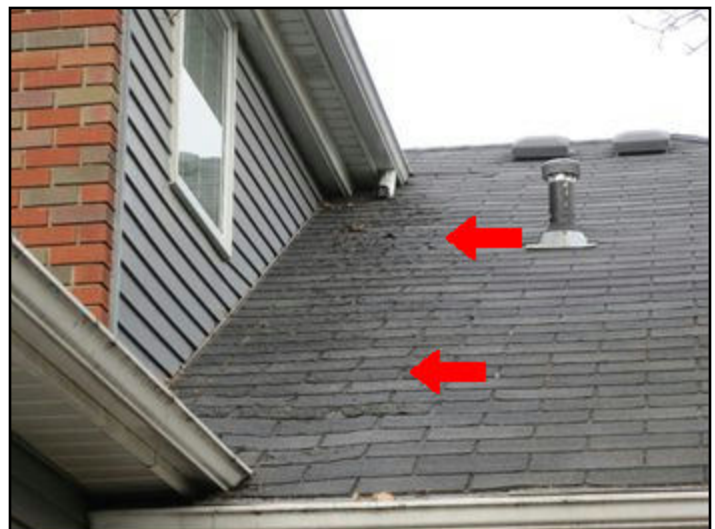
- Roof appears to be about 20 years old. Shingles significantly worn in many locations. Replacement needed. There is mold on the roof sheathing in the attic from condensation and poor ventilation - moldy sheathing should be replaced with shingles. Replace/seal all flashings (chimney, addition, etc.) as part of re-roof. Some of the sheathing boards are sagging, so for new shingles to lay flat some board replacement may be needed - roofer needs to assess all boards and replace as needed. To avoid moss growth on front (north) roof surfaces have roofer install galvanized strips.

2. Area of significantly worn shingles.

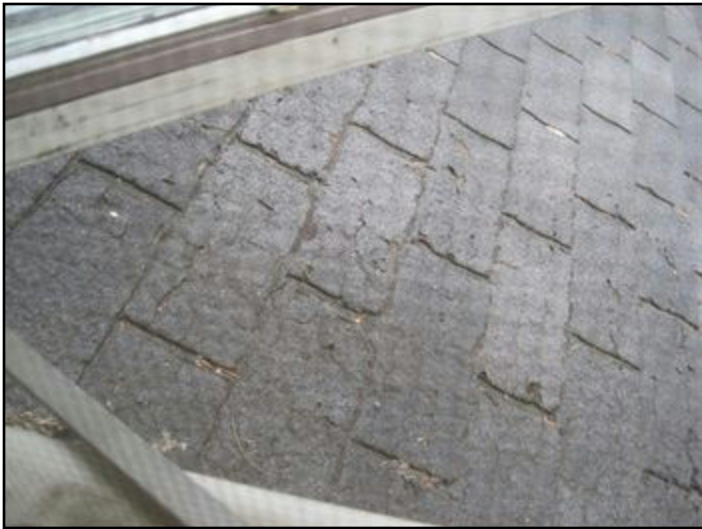
3. Significant shingle damage (example).

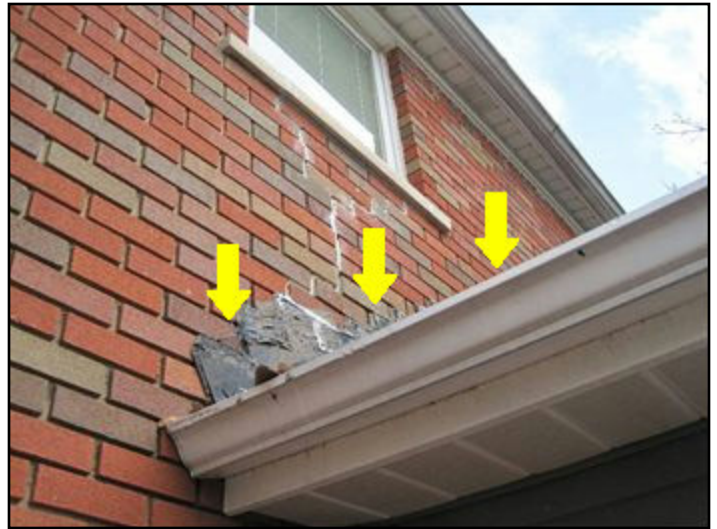
4. Re-flashing or re-tar flashing at addition.

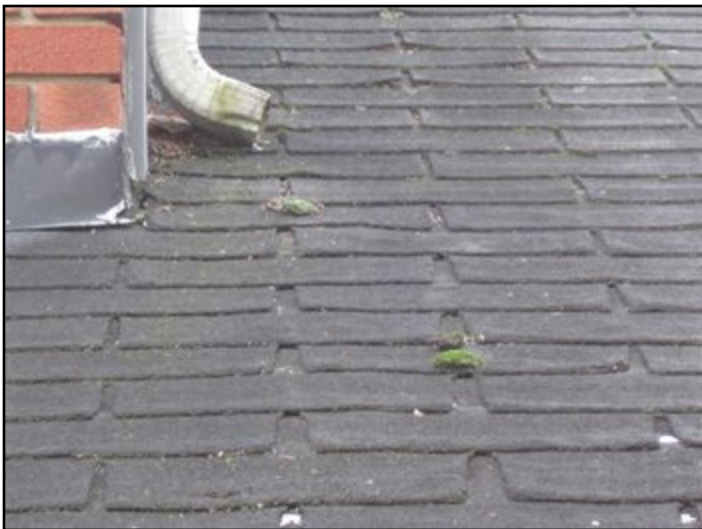
5. Worn shingles (example location).

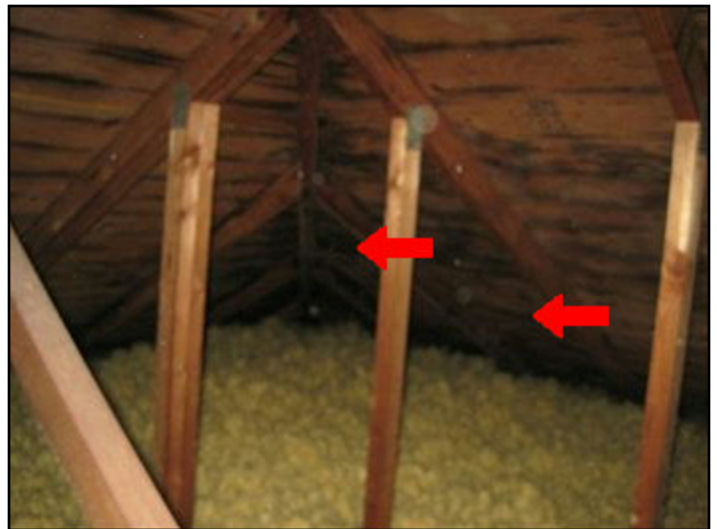
6. Mold on roof sheathing (NW corner of attic).

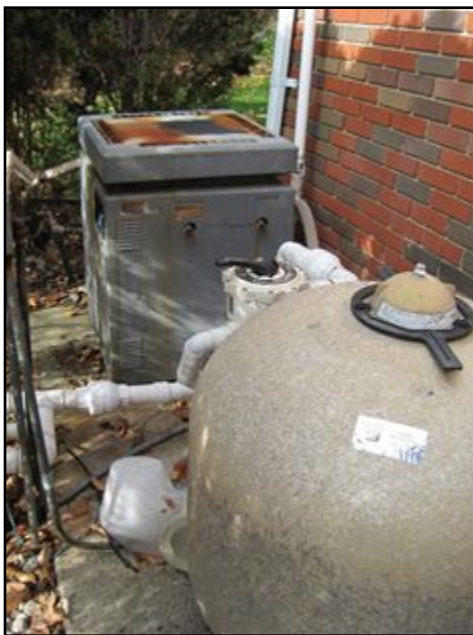
2. • In-ground pool system present - only checked in cursory manner for obvious concerns. The pump/filter/heater system is old and likely needs replacement or significant repair. Also, the diving board is damaged. The pool is covered so view of liner concealed. Expect significant cost for repair/upgrade - obtain estimates when weather permits.

7. Old pool filter/heater/pump system.

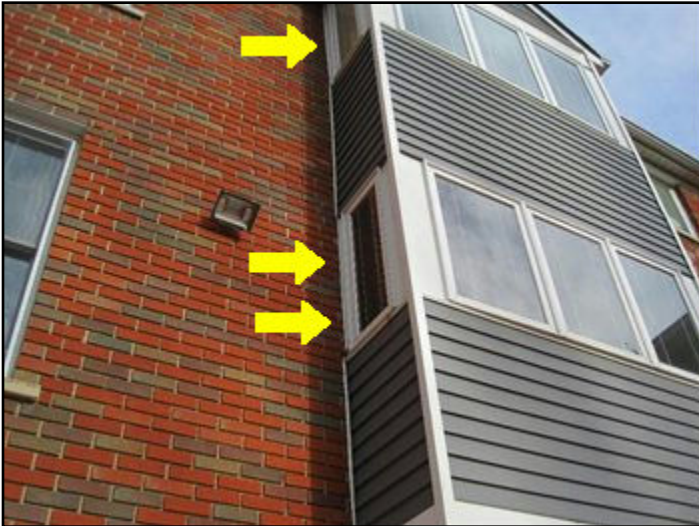
- Address: Caulk brick/trim interfaces where caulk missing (several - see example in photo below); damaged trim at garage door opening; level settled pavers at back walk; caulk cracked pool deck; clear trees away from house; repair gates as needed; clear gutter screens; caulk leaking gutter seams; window screens missing in several locations (some screens in basement); don't store heavy items at the garage ceiling (falling hazard).

8. Example of areas where caulk recommended.

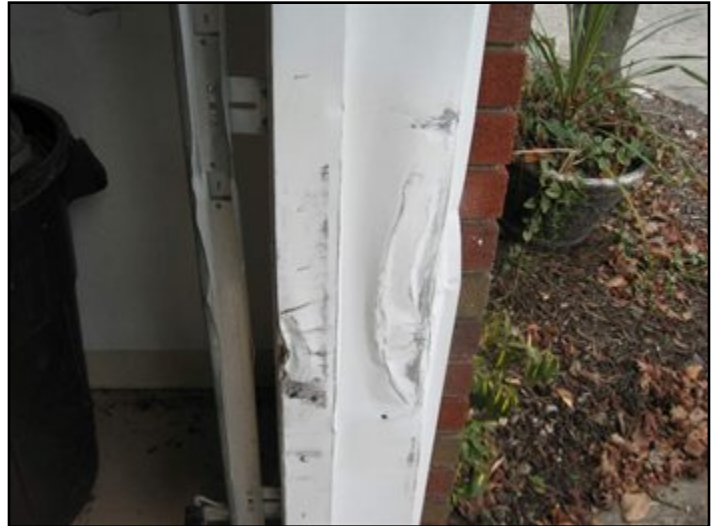
9. Damaged trim at garage door opening.

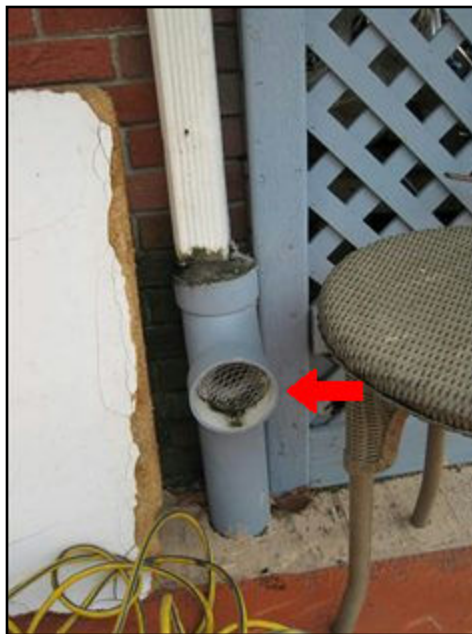
10. Open pipe at back downspout drain.

Task: Extend downspouts away from house; monitor buried drain in back for overflow - clear drain or extend downspout if clogged (see photo below).

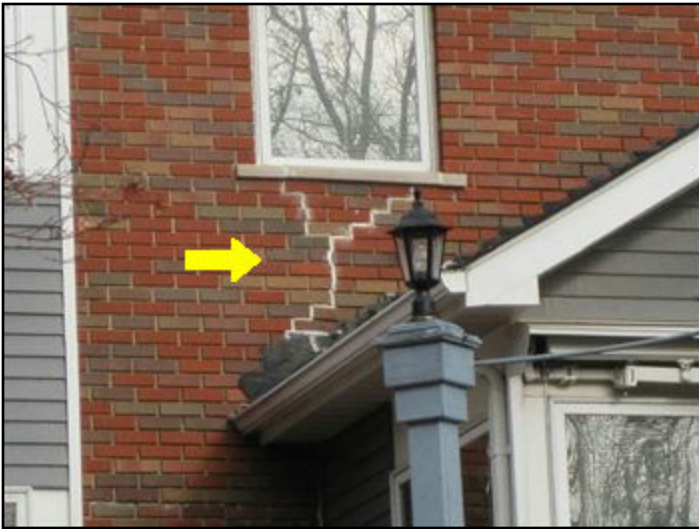
- Retain contractor to repair exterior brickwork as needed, including replacement of damaged bricks on chimney, repair of damaged brick above the back addition, and re-pointing on back. The cracked brickwork above the back addition appears due to settlement of the brick support structure which is concealed so can't be assessed. Often the support sag and then stay in place, but need to monitor for ongoing brick movement that could indicate the need for additional repair.

11. Area of cracks at brick joints in back.

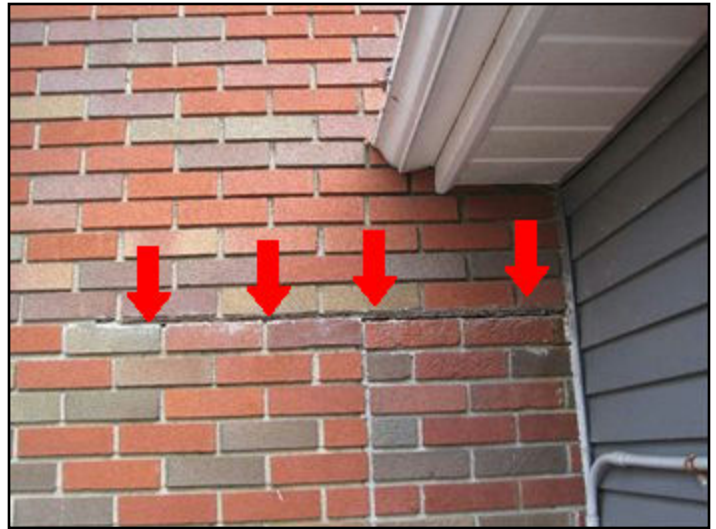
12. Re-point brick joint in back (fill w/mortar)

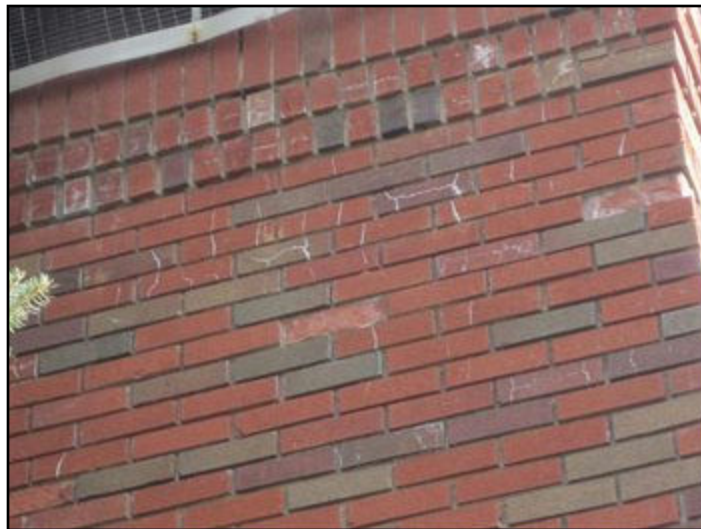
13. Cracked/spalled brick at chimney top.

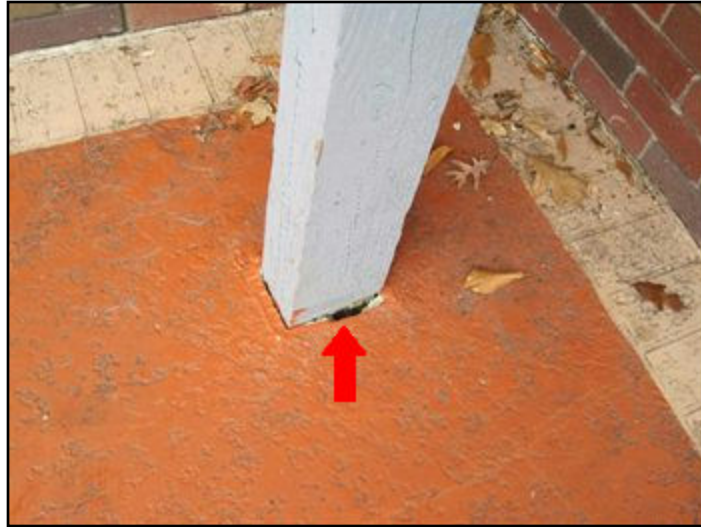
- Minor rot present at back deck posts where they are set in concrete - plan on eventually cutting off bottoms of posts and replacing with pressure-treated wood. Rot does not appear to be structurally significant at this time.

14. Rot progress at deck posts.

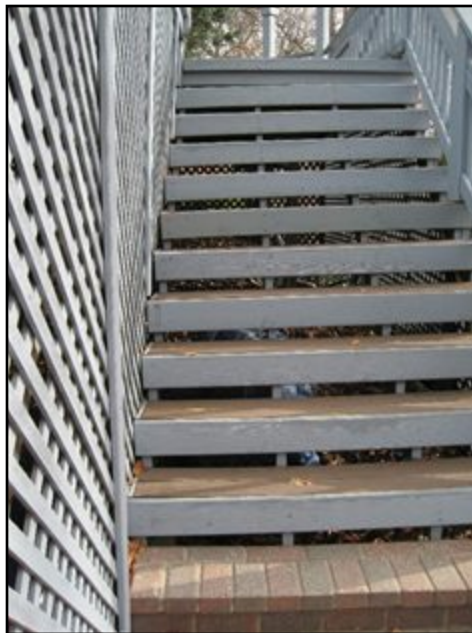
9. Condition: • The deck staircase in back is loose and tipped - repair needed to make solid. Also, there are rotted deck boards and other minor concerns - repair as needed.

15. Loose/tipped stairs at deck.

Cost: +/- \$500 to level/secure - more if replacement desired - obtain estimates for actual.

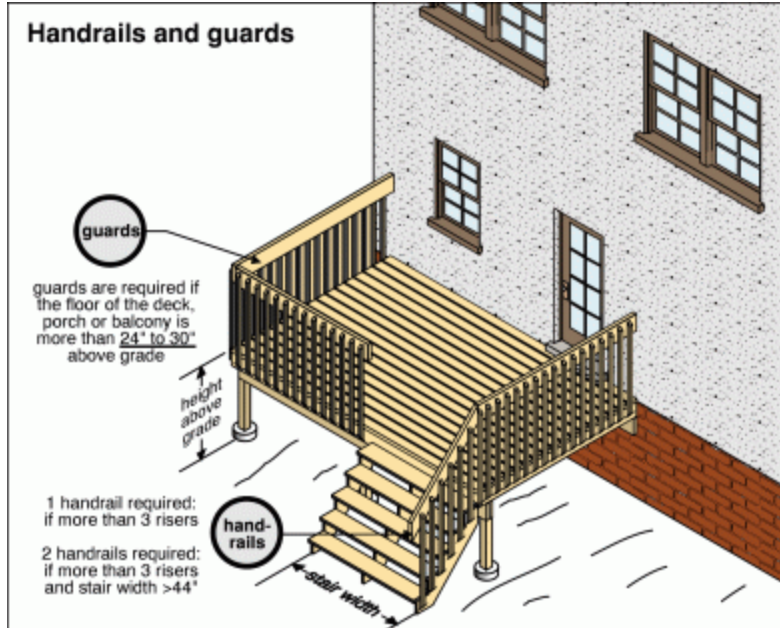
- Proper hand railing needed at back deck stairs (see picture below).

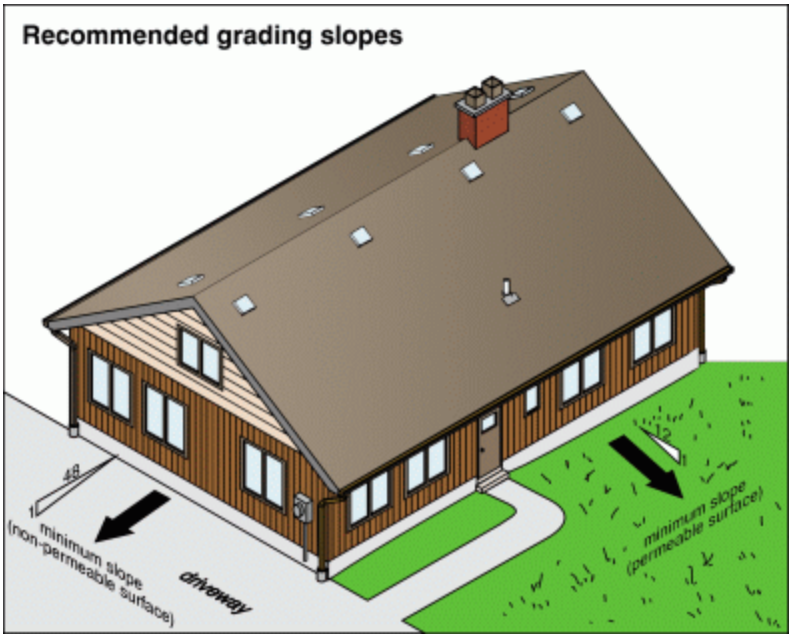
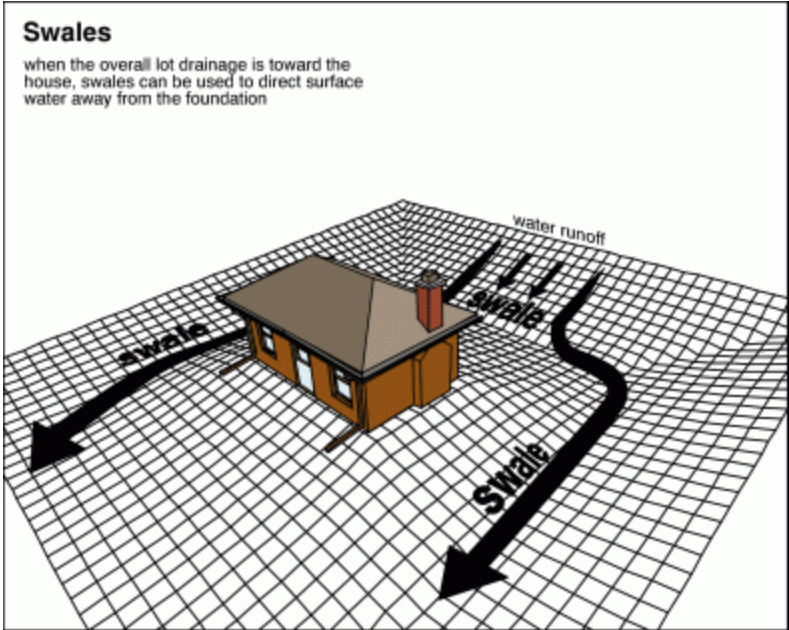
- The front yard and driveway slopes toward the house so rain can accumulate near the house thereby increasing the chance for basement leaks. Areas where water collects are evident. Need to re-grade and install French drains so rain readily drains around the house (not into the house). Also, need to clear ground down along the front of the house so wetness in soil doesn't weep through the brick and into the wall. Leak stains are evident in the basement at top of the foundation, cracks, and plumbing drain, so leaking could be active (active leak at main drain - separate report items - Plumbing, Interior, and Exterior sections).

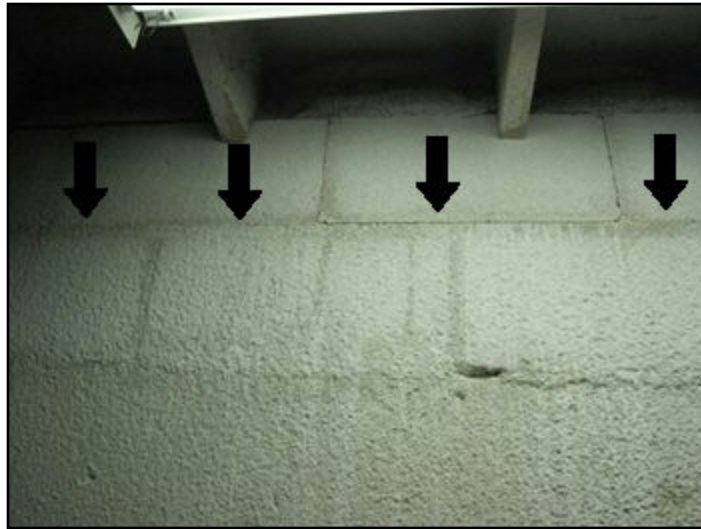
16. Leak stains at block foundation near furnace.

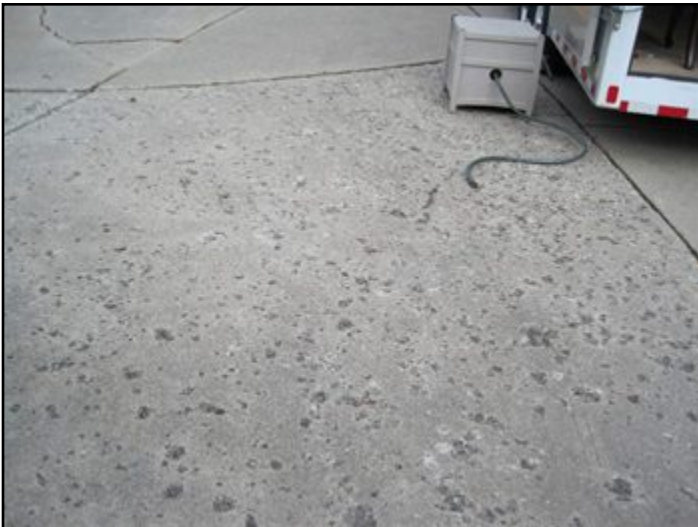
- Significant driveway cracks, spalling, and tripping hazards - repair, level, replace as desire/needed. Replacement cost +/- \$5 per square foot. Calculate based on amount to be replaced, unless only patched. Replacement of all significantly damaged sections +/- \$4,000 - obtain estimates for actual.

17. Spalled driveway.

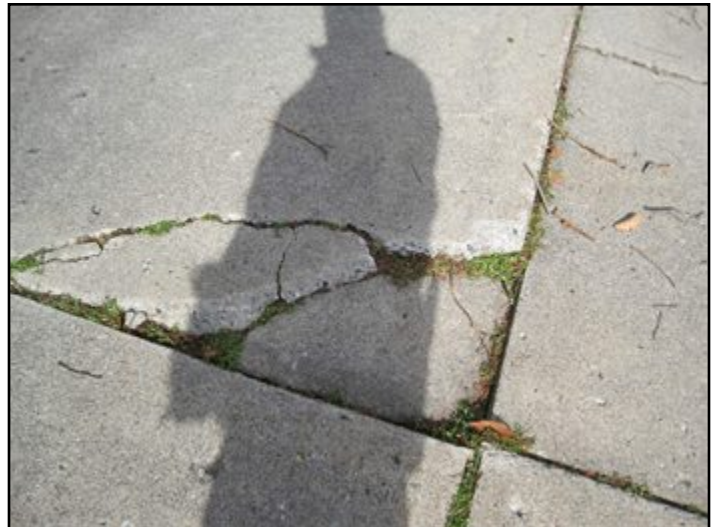
18. Driveway damaged (example).

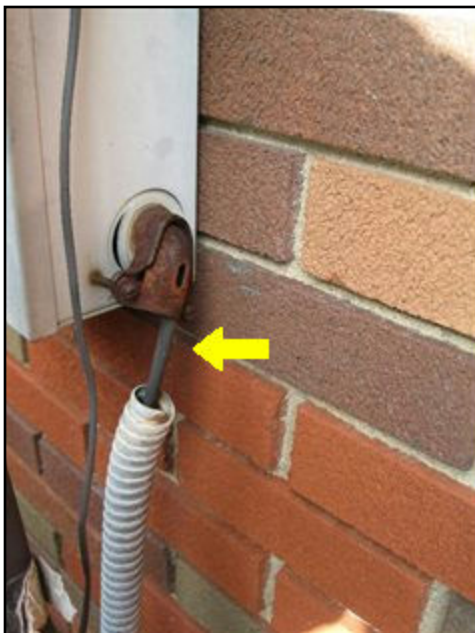
19. Open conduit at AC subpanel in back.

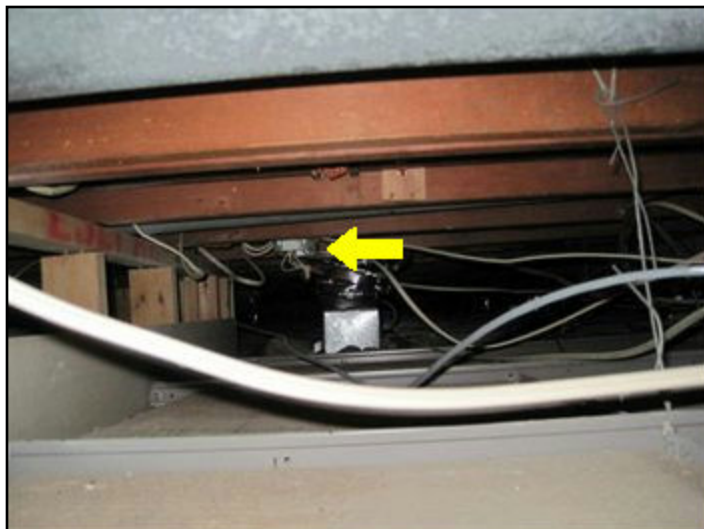
20. Open junction box, loose wire above ceiling.

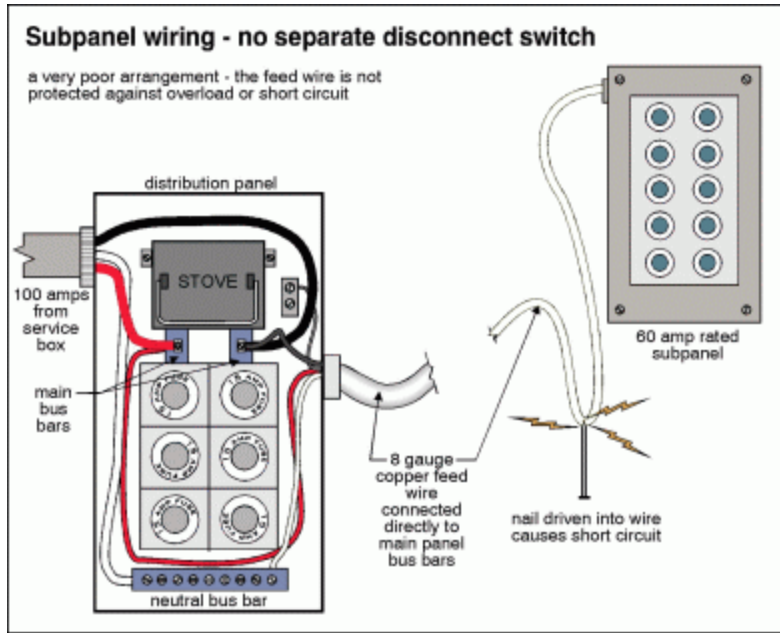
- 19. Condition: • [No fuses or breakers for subpanel](#)
 - The pool system/basement circuit breaker panel next to the main is not tapped off a breaker so when the main panel main breaker is shut-off this panel is still live. Tapping off a 220v breaker in the main panel is recommended.

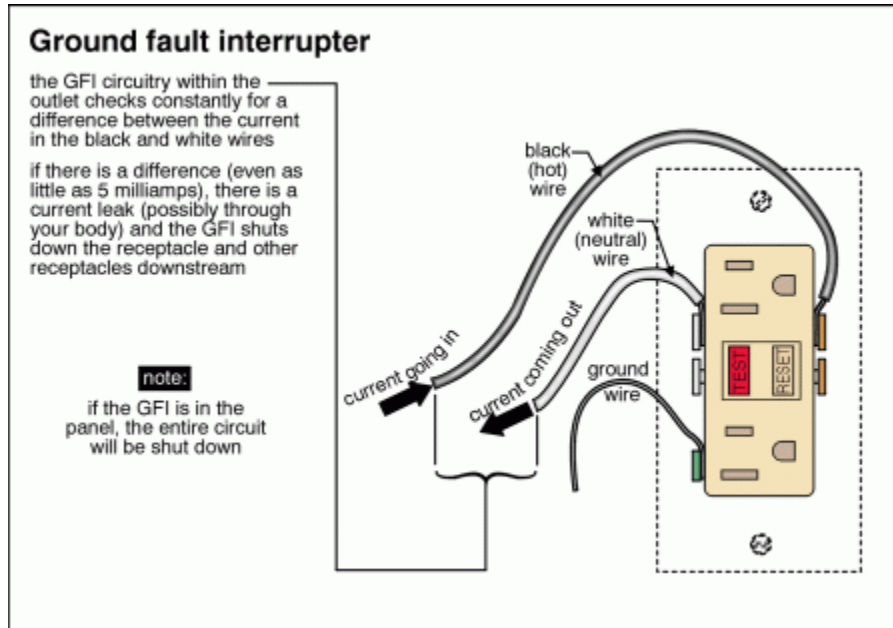
- GFIs missing or faulty in several locations. Installation needed at kitchen counters, bars, unfinished basement areas, bathrooms, and shower light. Replace faulty units in the garage, outside and at bar sink in the living room. Replace/install as needed, then test all locations: Bathrooms, kitchen counter, unfinished basement, outside, and garage.

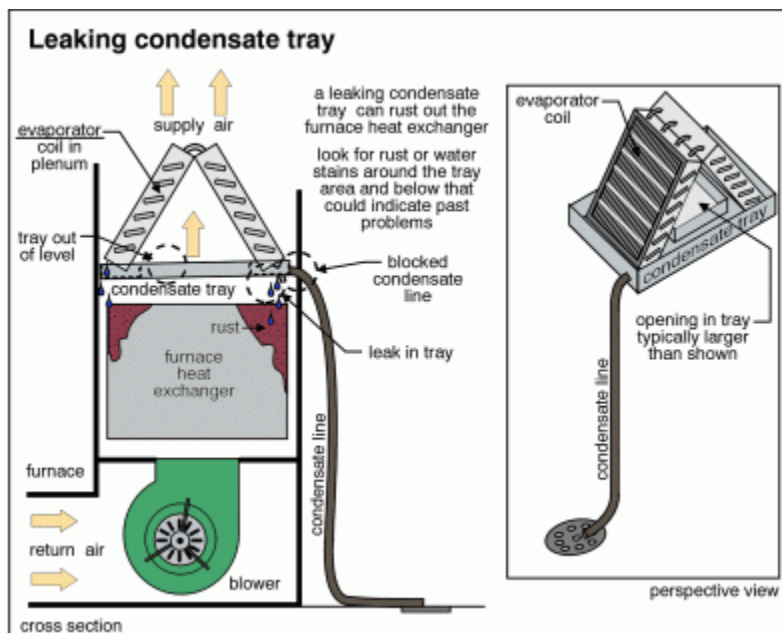
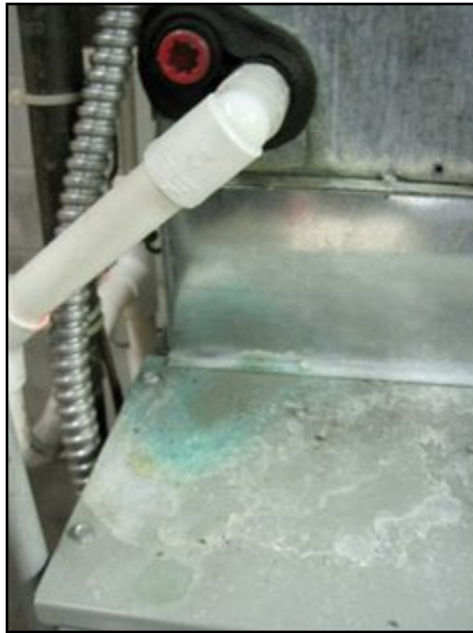
- Dry condensation stains are present on top of the furnace below the condensate drain line. Monitor this area during heavy air conditioning use in the summer - repair leaks if become evident (minor cost if repair needed).

21. Condensate leak evident at furnace.

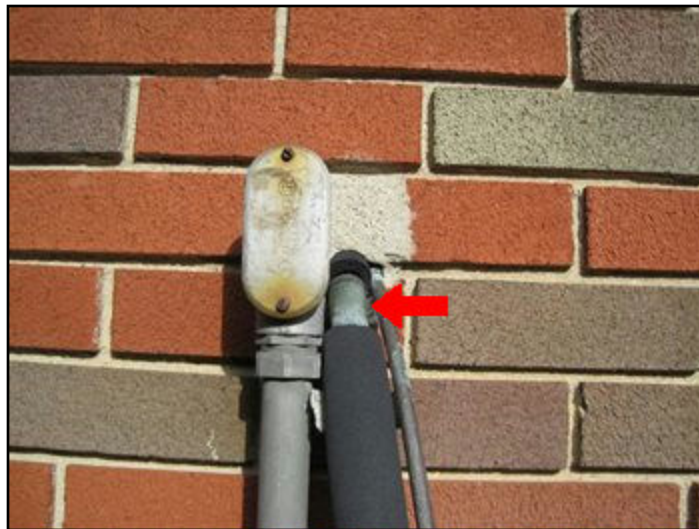
29. Condition: • Replace damaged/missing insulation on outside refrigerant lines.

22. Insulation missing for refrigerant lines-back

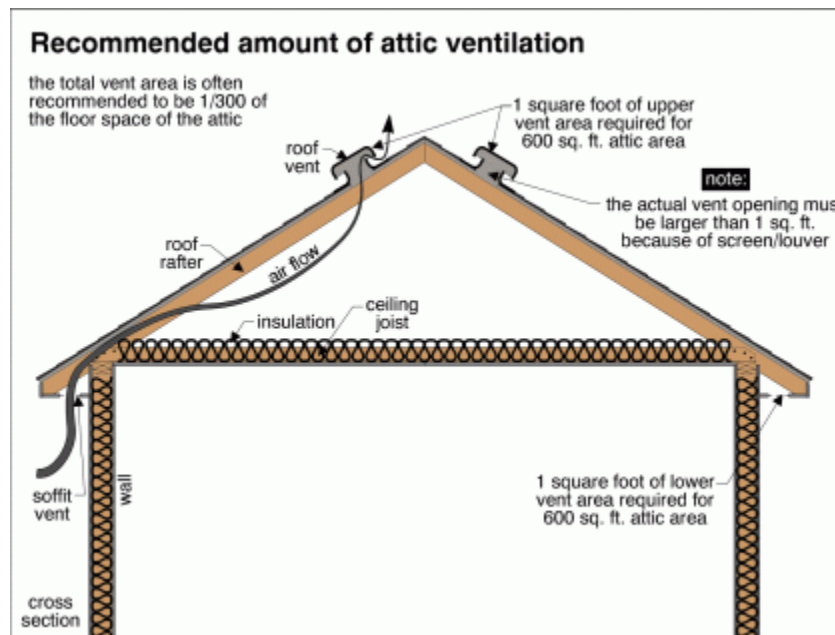
- 33. Condition:** • [Inadequate](#)
 - Installation of additional soffit venting recommended at re-roof: Either Smart-Vent or drip edge vent.

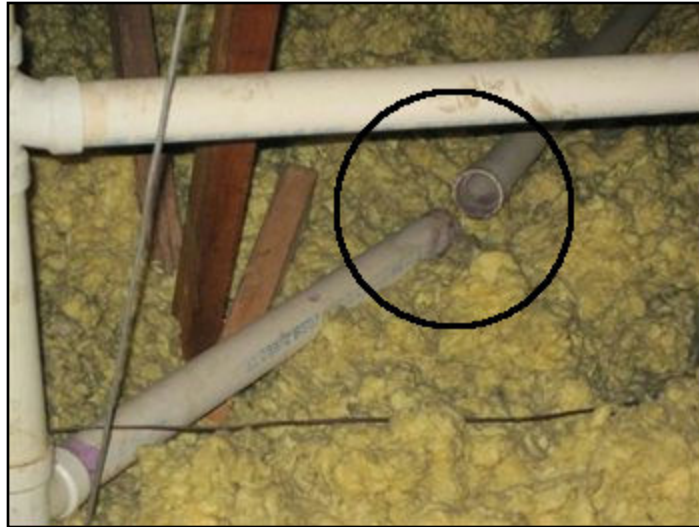
39. Condition: • Plumbing vent pipe is disconnected in the attic, re-glueing needed.

23. *Disconnected plumbing vent pipe in attic.*

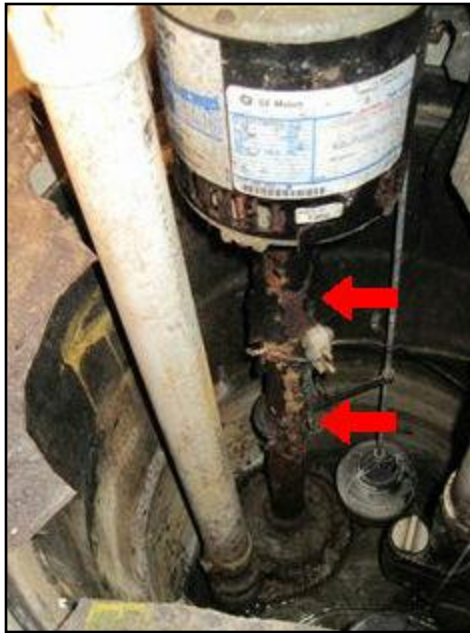
24. Rusted sump pump pipe.

Task: Also, inquire with seller about any flooding conditions that may have occurred and details as to cause and repairs made (installation of back-up sump pump and flood line near circuit breaker panel likely indicate past flooding).

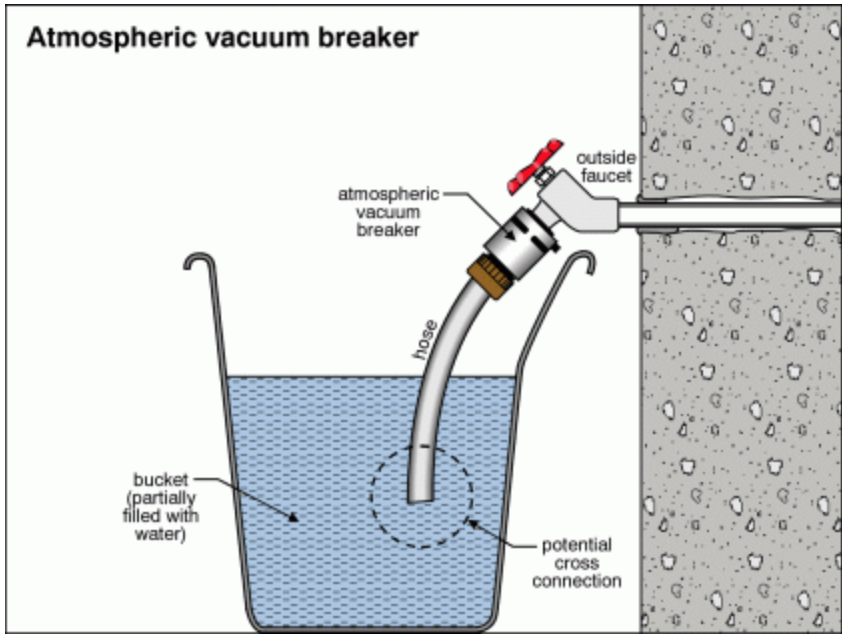
44. **Condition:** • [Backflow prevention missing](#)

Task: Install vacuum breakers at hose bibbs (see picture below).

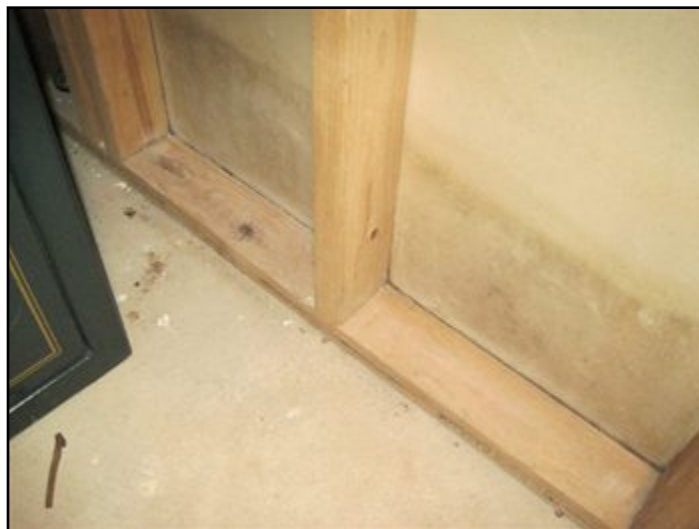
- Wash mold from surfaces in the furnace room, around the sump pump, in the northeast basement closet, and in the circuit breaker closet. The mold in the circuit breaker closet could indicate past sewer back-up, flooding due to sump pump failure, or leaks at the main drain/foundation interface (stains at this location in breaker room). Inquire with seller about cause or past flooding. Need to maintain outside drainage, repair the sump pumps, and repair foundation leaks to avoid conditions conducive to mold. Mold does not appear to be a significant health issue at this time. If mold smell develops plan on checking behind concealed drywall via test holes (cleaning personnel at house during inspection cleaning basement - mold smell not present, but cleaning products and vacuuming made smell assessment limited - multiple dehumidifiers likely indicates musty conditions) - remove any present. Also, ventilate basement closets to prevent mold.

25. Mold on drywall in basement, at water meter..

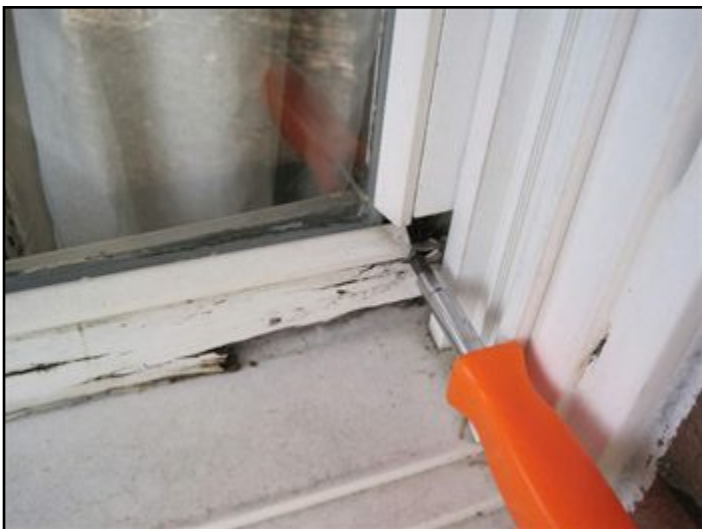
49. Condition: • Window repairs needed: Significantly rotted sash (and sash falling apart) in the living room, window balance broken (won't stay open) in the northeast bedroom, and mutton bars broken in the master bedroom.

26. Rotted window (living room window).

Cost: +/- \$500 - obtain estimates for actual.

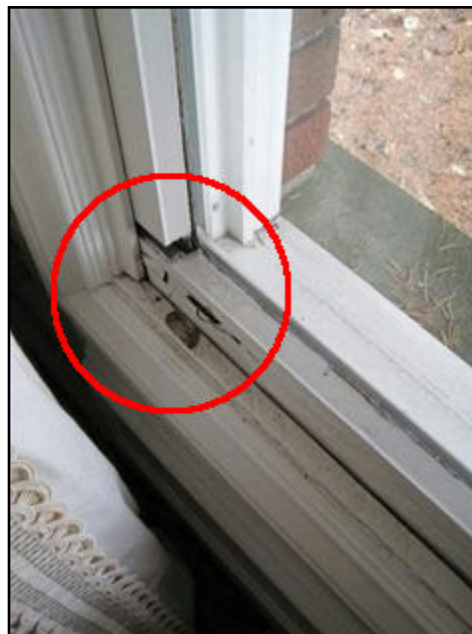
27. Significant rot at living room window.

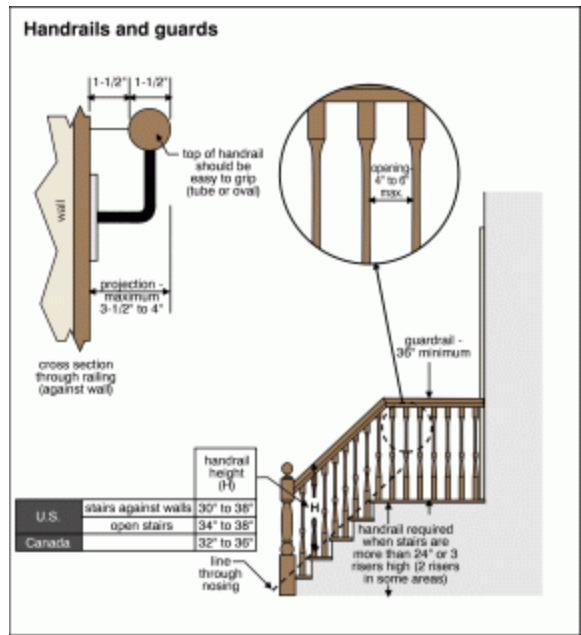
- Proper graspable hand rail missing at half of the stairs to the top floor - replacement recommended.

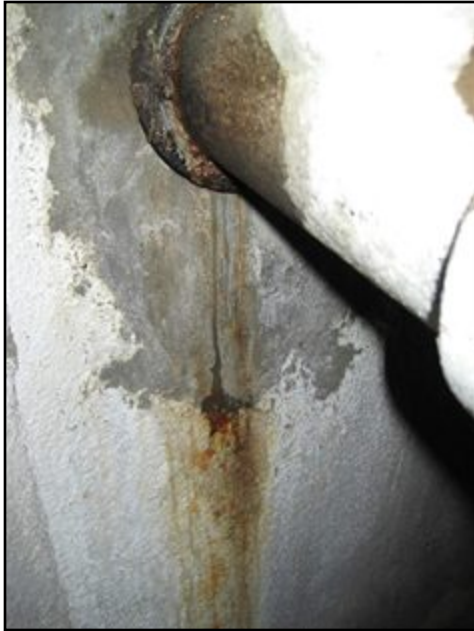
Leak stain (dry) evident at a hairline foundation crack in the furnace room (north wall) and active leak evident at the main sewer drain in the circuit breaker room (basement). Injection-sealing can be used to stop leaks. Also, need to maintain outside drainage (especially on the north side of the house - see other report items for information about minimizing chance for basement leaks) so rain doesn't drain against the house - to minimize chance for basement leaks.

28. Active leak at main drain near water meter.

Cost: +/- \$350 to injection-seal each location.

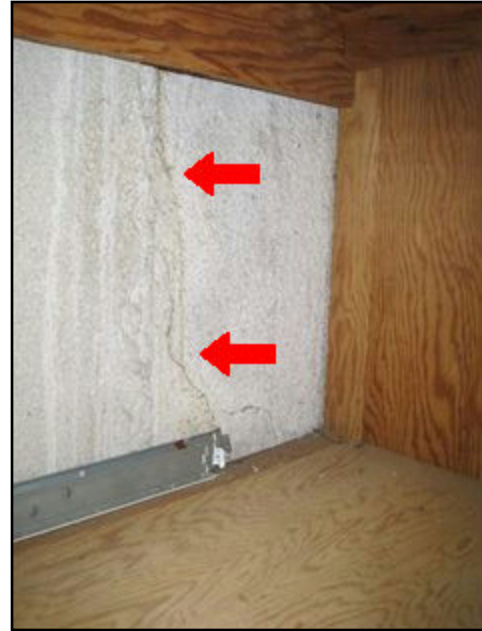
29. Leak stains at foundation crack.
