INSPECTION REPORT

For the Property at:
21309 WOODHILL DR.
FARMINGTON HILLS, MI 48167

Prepared for: SHRIDHAR KULKARNI
Inspection Date: Saturday, December 4, 2010
Prepared by: David Richardson

RE: Report No. 1845
21309 Woodhill Dr.
Farmington Hills, MI
48167

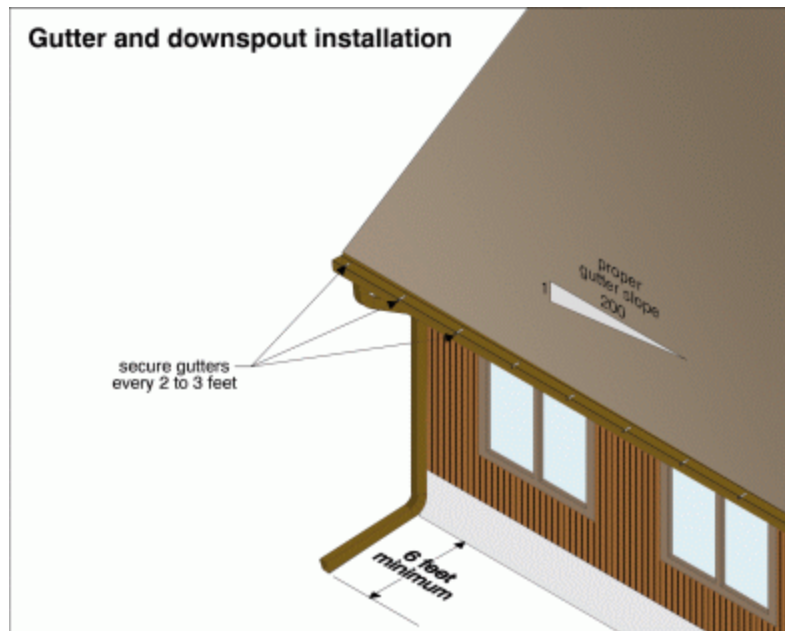
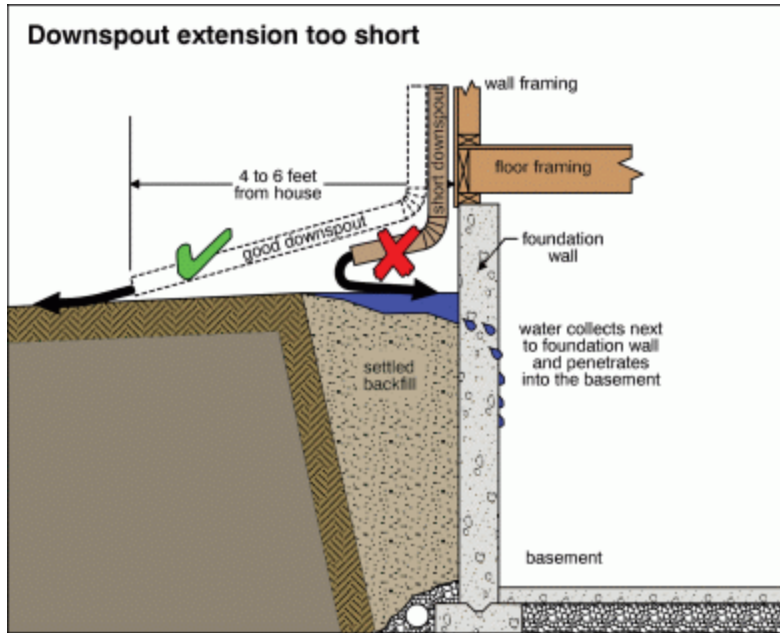
6. Condition: • [Downspouts end too close to building](#)

Task: Extend downspouts away from house; monitor buried drain in back for overflow - clear drain or extend downspout if clogged (see photo below).
